**PHASE I RECONNAISSANCE
SITE CHARACTERIZATION REPORT
FOR THE
SILVER CREEK DRAINAGE PROJECT**

Lewis & Clark County, Montana

**Olympus Technical Services, Inc.
765 Colleen
Helena, Montana 59601**

February 2003

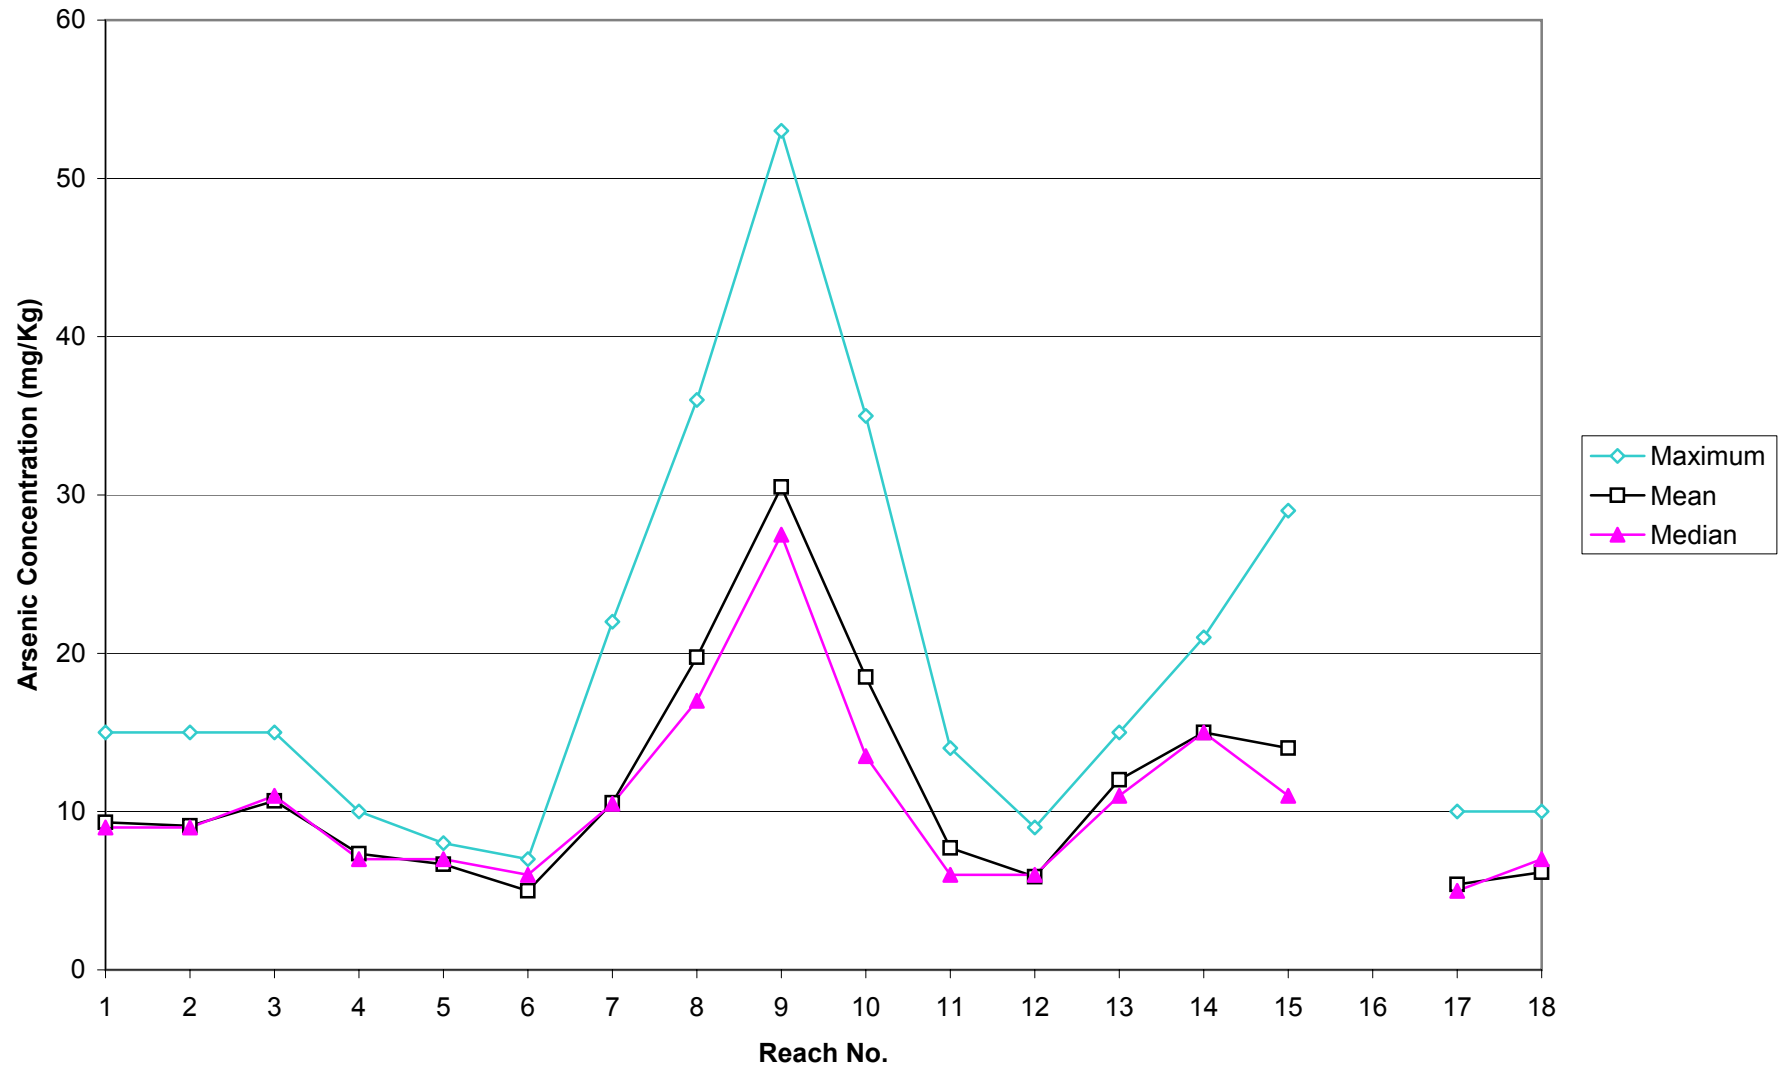
Figure 6-4a. Arsenic in Silver Creek Stream Sediments by Reach

Figure 6-4a shows that the maximum, mean and median arsenic concentrations generally follow similar trends from reach to reach. The lowest maximum, mean and median arsenic concentrations occur in Reach 6, which is located upstream from the Goldsil tailings area. The arsenic concentrations increase below Reach 6 to a maximum in Reach 9 and then decrease. Arsenic concentrations are at another low in Reach 12, which is located south of the largest placer tailings and directly upstream of the pipeline crossing. Arsenic concentrations increase again below Reach 12. Reach 16 was not sampled because no land owner access agreement was in place. Arsenic concentrations decrease again in Reaches 17 and 18.

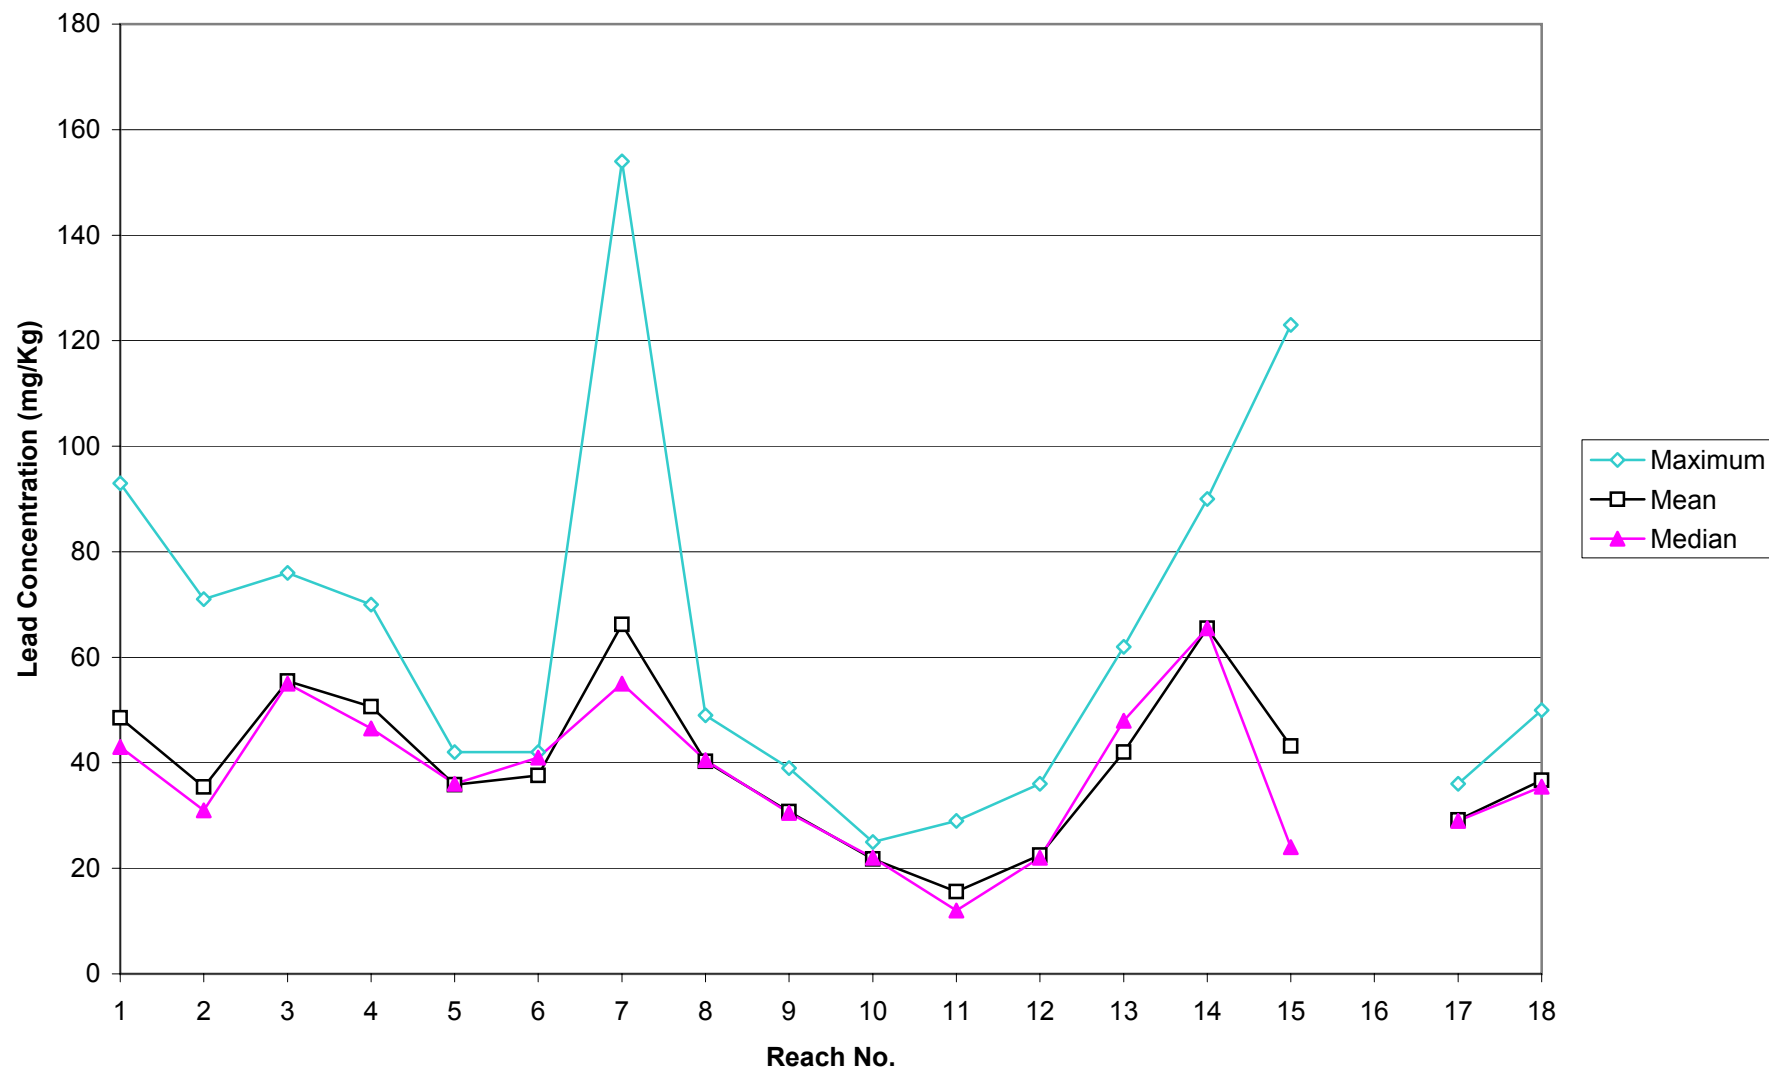
Figure 6-4c. Lead in Silver Creek Stream Sediments by Reach

Figure 6-4c shows that the maximum, mean and median lead concentrations follow generally similar trends from reach to reach (with the exception of Reach 15, which shows diverging trends for maximum and mean/median lead). The maximum, mean and median lead concentrations increase sharply below Reach 6 to a peak at Reach 7, then decrease to minimum values in Reaches 10 and 11. The maximum observed lead concentration occurs in Reach 7. The lead concentrations increase again below Reach 11, with peak mean and median values occurring in Reach 14 that are higher than in Reach 7. The second highest lead concentration occurs in Reach 15. Lead concentrations show another increasing trend in Reaches 17 and 18.

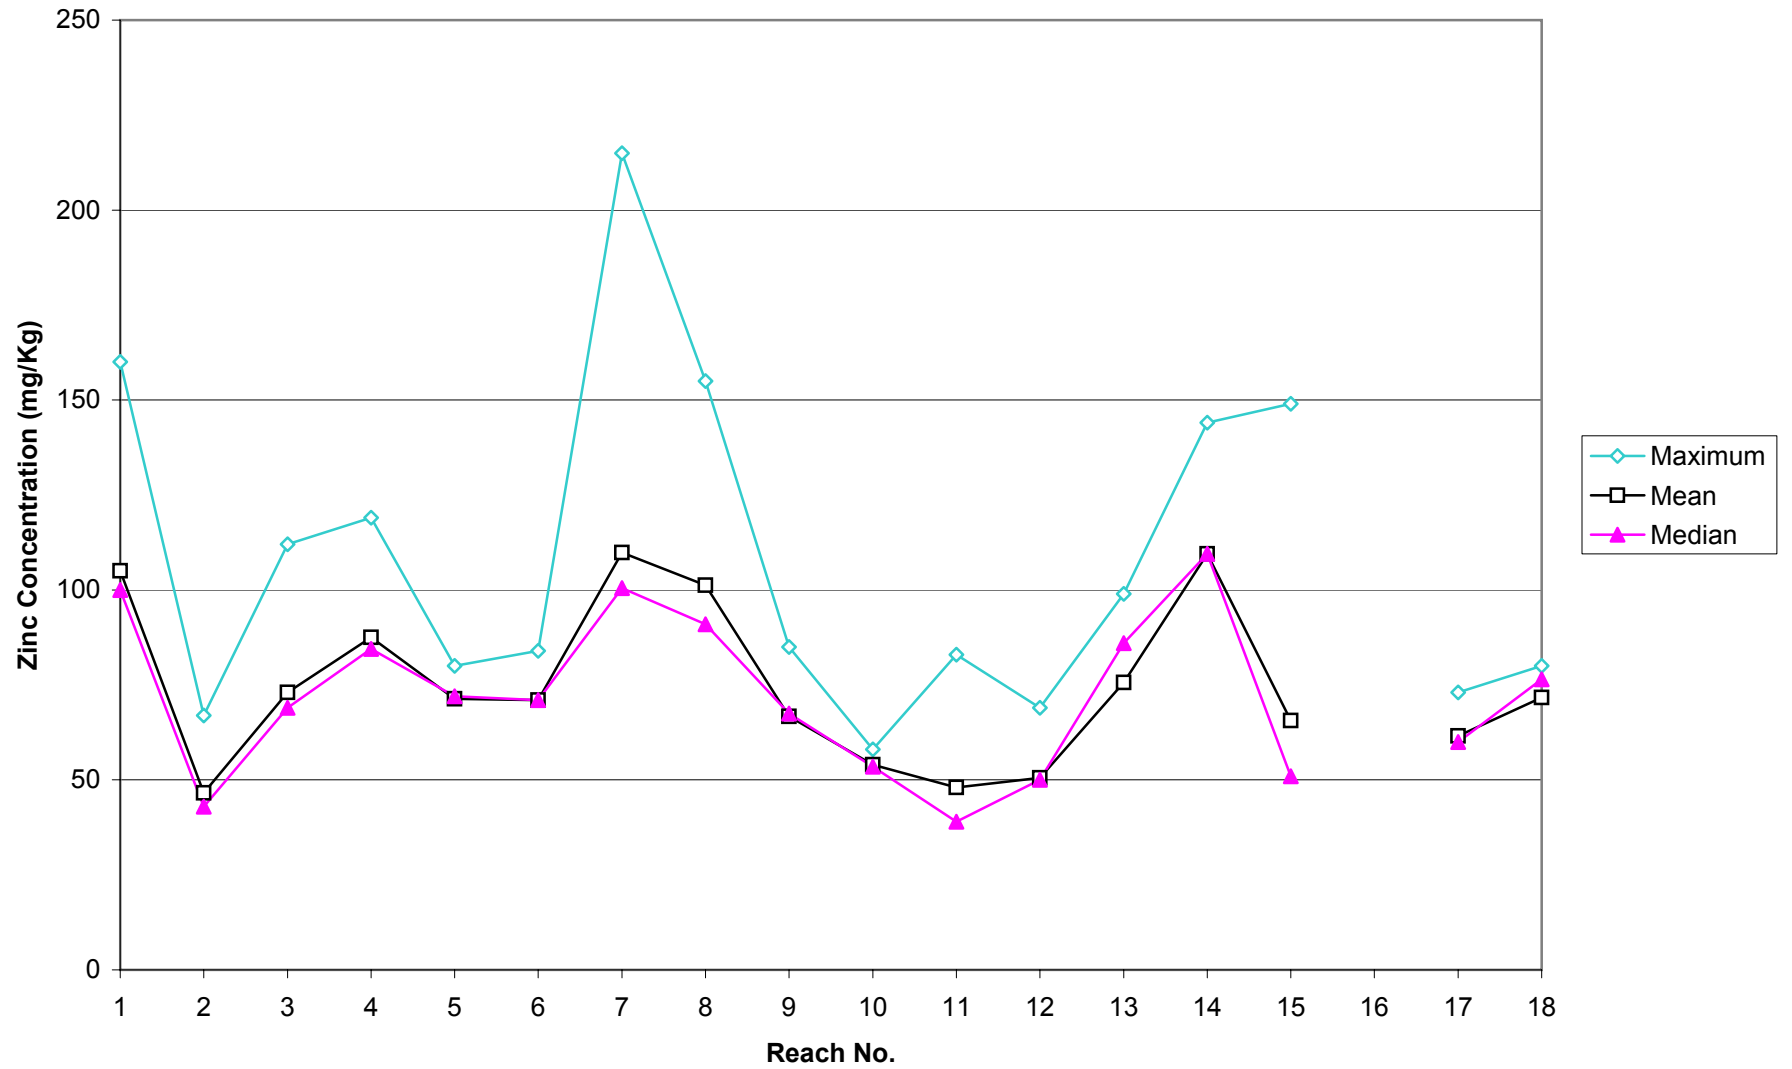
Figure 6-4e. Zinc in Silver Creek Stream Sediments by Reach

values occurring in Reach 14 that are approximately the same as the peaks in Reach 7. Zinc concentrations show another slight increasing trend in Reaches 17 and 18. The maximum observed zinc concentration occurs in Reach 7. High zinc concentrations also occur in Reaches 1, 8, 14 and 15.
